# AN INDEPENDENT REVIEW OF COALBED METHANE RELATED WATER WELL COMPLAINTS FILED WITH ALBERTA ENVIRONMENT

Prepared by: Alexander Blyth, P.Geol., Ph.D.

Alberta Environment 10th Floor Oxbridge Place 9820 - 106 Street Edmonton, Alberta T5K 2J6

January 16, 2008

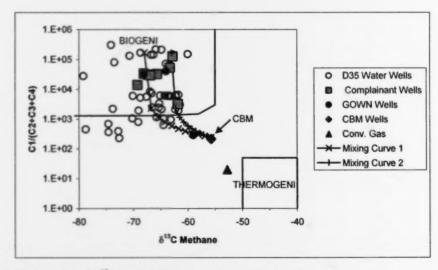
Figure 6 Mixing plot of 513C methane versus the methane/C2+ ratio.

It is possible for gases with different origins to mix with each other. For example, mixing curves 1 and 2 (Figure 6) mix a naturally occurring biogenic gas with typical CBM gas. These curves show that up to 4% of the total gas in the complainant wells could theoretically be of CBM origin. However while gas mixing is possible, the gas composition and δ¹³C methane value of the complainant wells is not statistically different from the average D35 water well values in the areas. Therefore it cannot be concluded that mixing of biogenic and CBM gas has occurred.
